**Mt. Abraham Union Middle/High School**  
Bristol, Vermont

## **Feasibility Study Update #1**

### **Site & Building Assessment Progress**

**June 4, 2013**

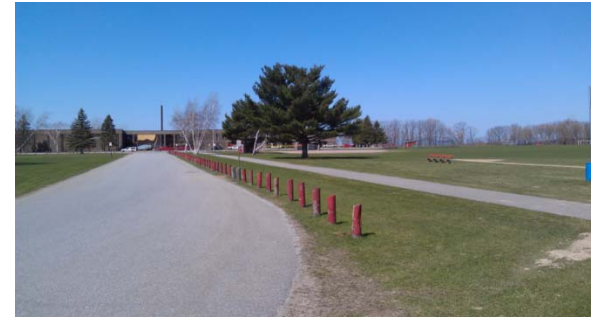
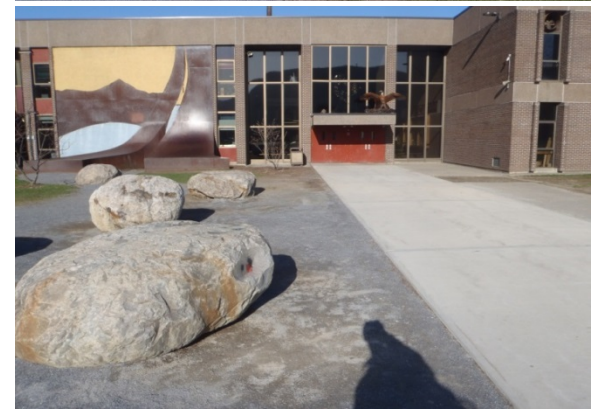
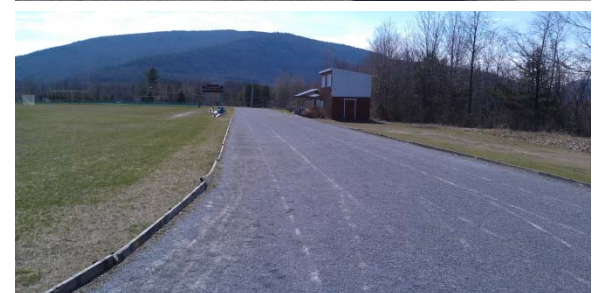
- Site Pavement is in good condition
- Paint pavement stop-bars at intersection of Airport Drive and Vermont Route. 17
- Replace the entrance gate
- Consider pedestrian/vehicle separation from bus loading area
- Add signage to delineate traffic patterns and segregated parking areas
- Replace wood bollards
- Consider screening fences and dumpster pad
- Construct additional sidewalks along direct walking routes
- General grading and re-vegetation
- Fields are well maintained – track edging boards need replacement; wood structures need maintenance

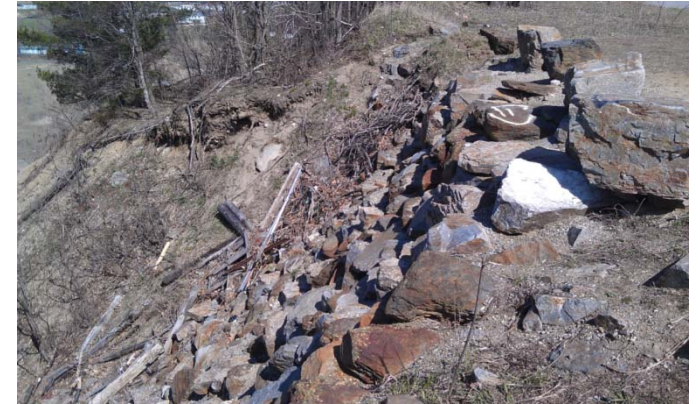
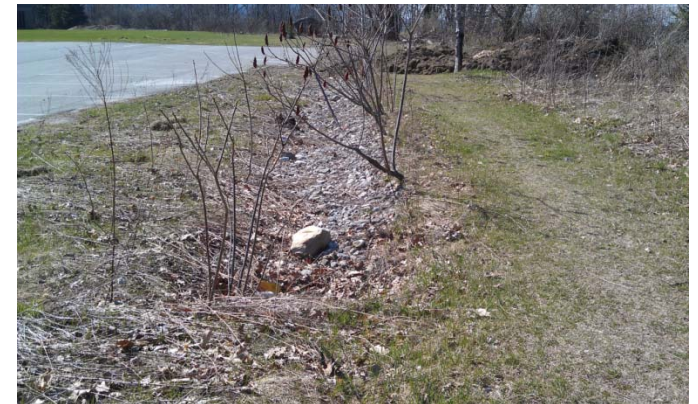
- Commission a comprehensive survey
- Subsurface soil samples should be performed
- Site is relatively flat
- Surface erosion at the escarpment – stone addresses top, not lower portion
- Determine if current water supply will support sprinkler system
- Replace septic tanks and dosing pump (not vented) – preventative measure
- Drywells appear to be adequately functioning; no standing water observed
- Appropriately size storm drainage pipe around building for water from roof
- Construct a conveyance channel for stormwater during large storms

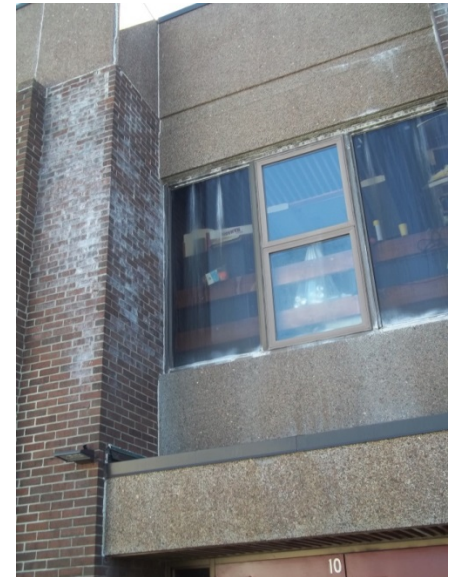
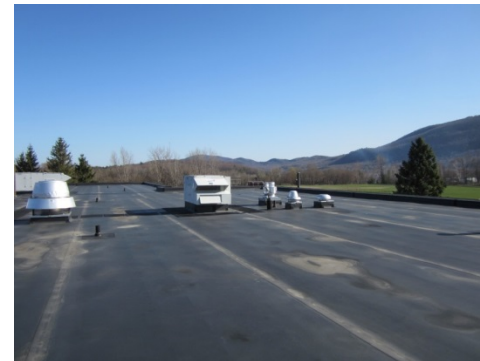
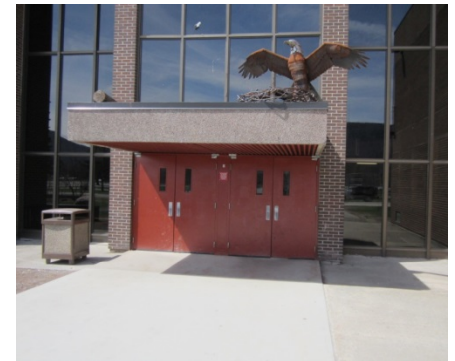
- Brick masonry walls are in good condition. Some efflorescence noted. Limited areas exhibit cracking at precast panels and should be re-caulked.
- A few of the original windows have lost the seal and should be replaced.
- Heavily used exterior doors show wear and should be replaced.
- EPDM roofing system installed in 2004 appears to be in good condition.

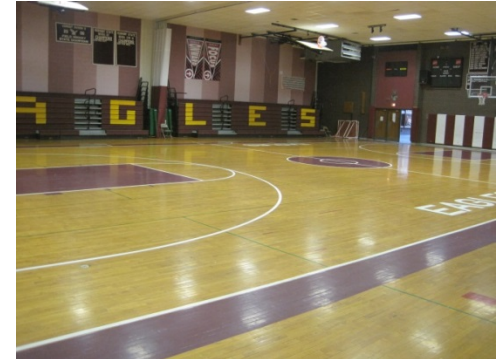
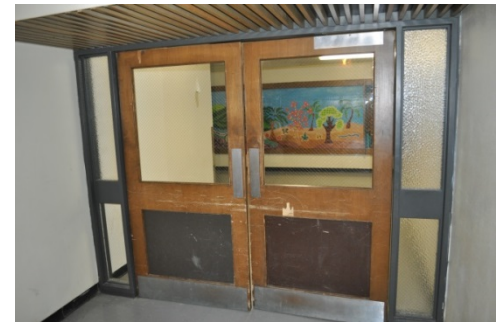
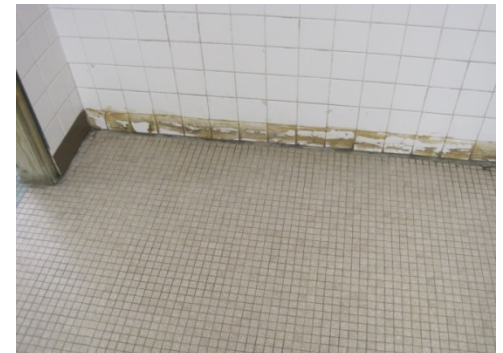
- Overall Aesthetics (tired finishes)
- Flooring: VAT, Carpet, VCT, Quarry Tile, Ceramic Tile, Wood floor, Raised rubber tile, Sheet flooring; all in various conditions. Wood floor in gym is worn, has dead spots and warrants replacement. Vinyl base should be replaced in most locations.
- Walls: Vinyl-faced wall board is peeling in most locations; Painted CMU or GWB, ceramic tile and brick; some cracking noted.
- Doors and low window sills are worn and warrant replacement
- Ceilings: Wood slats and mostly suspended ACT, some stained.

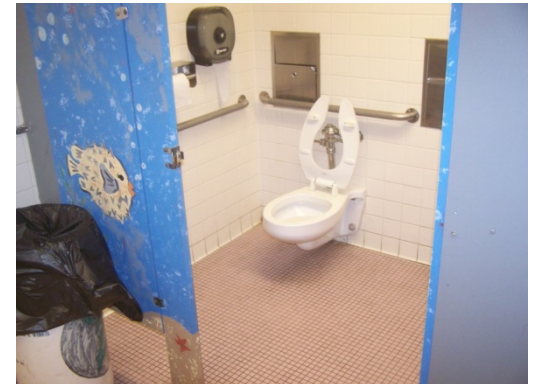
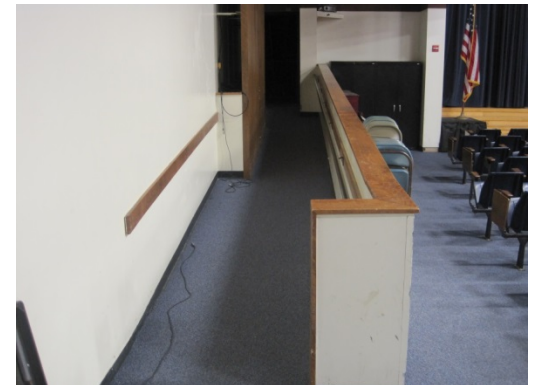
- Line of sight between main office and entrance
- Open campus concept

- Barrier free access
- Room Signage
- Auditorium: Accessible route to stage from within auditorium, slope of ramps, companion seats
- Elevator is undersized
- Some toilet room fixtures do not comply with regulations
- Fire Alarm notification devices (speakers and strobes) do not meet current requirements in all areas

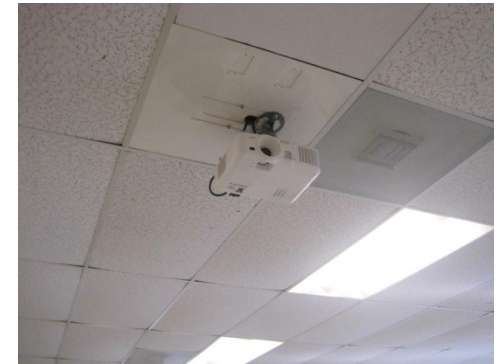
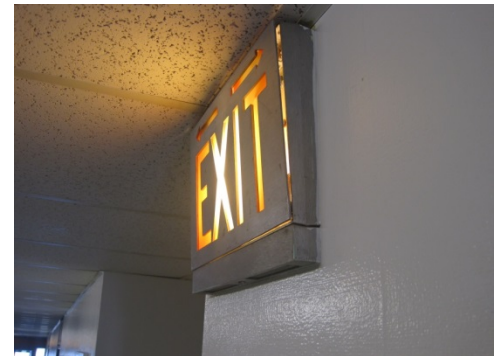
- No fire suppression sprinkler system (except boiler room)
- Smoke detectors should be installed in all egress areas, hallways and classrooms; fire detection devices are required in all areas.
- A new, addressable fire alarm system is recommended.
- Electrical panels/equipment should have a 36"-42" clear space in front of them.
- All exit doors should have emergency lighting with battery back-up and exterior fixtures with adequate egress lighting.
- Provide emergency lighting at egress paths.
- Receptacles for ceiling mounted projectors should be flush with ceiling tiles.
- Curtain at stage should be fire-rated.

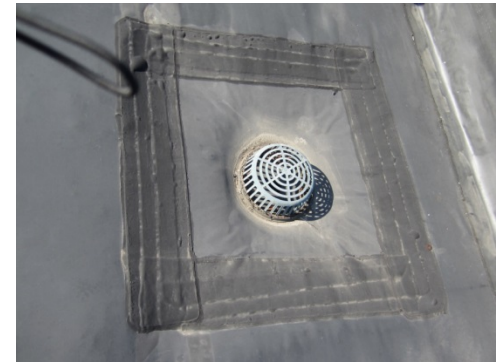
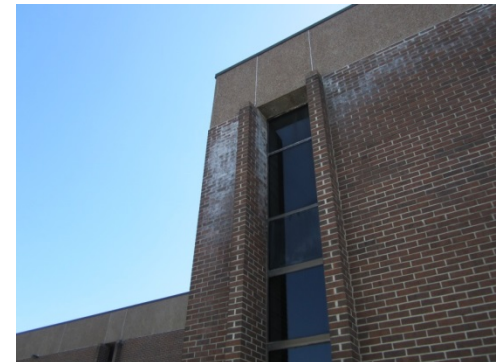
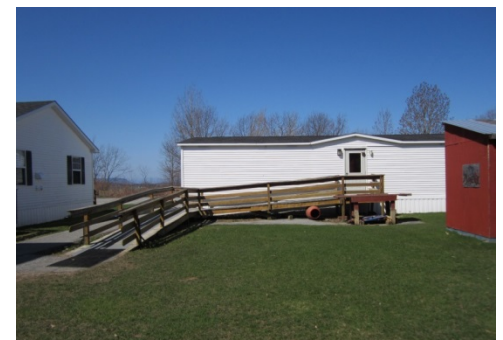
- Generally the structural system (moment frames) is performing adequately
- Some localized masonry cracking at corners due to thermal movement
- Efflorescence at pool area should be cleaned; repoint mortar joints
- 2004 addition can support an additional floor
- Roof should have a secondary drainage system added if redone
- Replace portable CR foundations, ramps/stairs and handrails.
- Seismic Code Compliance

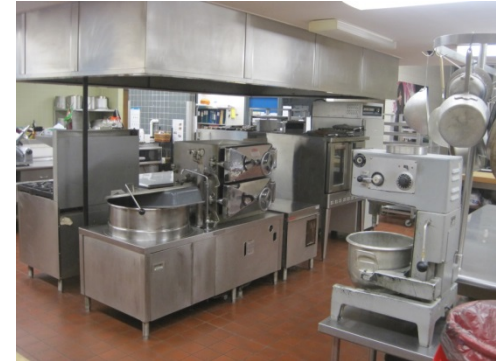
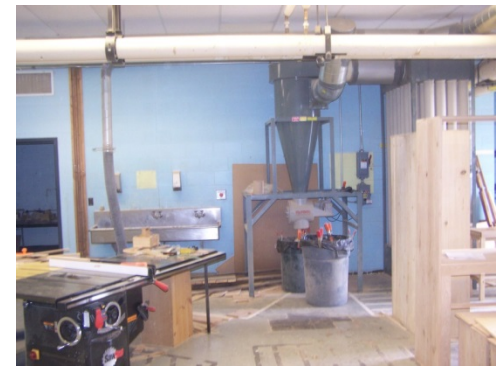
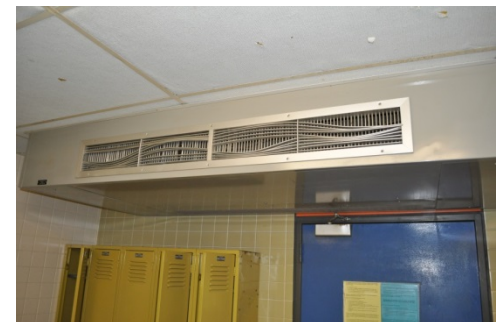
- Energy / efficiency improvements: Add occupancy/ CO2 sensors
- Boilers installed in 1988; Bio-mass heating system installed in 2007
- Test, balance and/or service mechanical/ heating systems
- Add ventilation at corridors/toilets
- Kitchen – install makeup air unit; replace exhaust system; add Ansul system and shut-off valve
- Replace AHU with energy RU at auditorium and gym
- Some pneumatic controls remain and should be replaced with DDC
- Replace remaining UVs and consider more efficient system
- Duct systems require cleaning
- Relocate dust collector outside

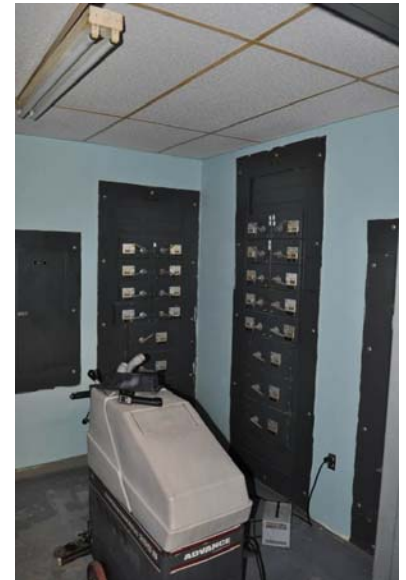
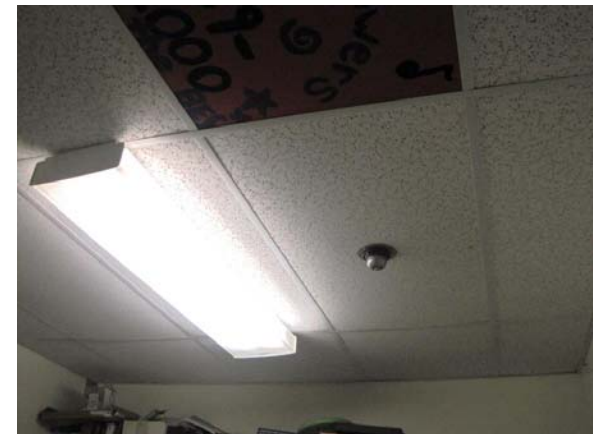
- Electrical distribution system is in good working order.
- Consider replacing original 1968 equipment
- Consider upgrading Sound and Stage Lighting in Auditorium
- Wraparound light fixtures should be replaced with direct/indirect fixtures.
- Occupancy sensors should be added to all spaces.
- Interconnect the phone and data systems.
- Install a new data system though out that can handle an integrated security and phone system. Install wireless access points in each classroom.
- Relocate slop sinks from electrical rooms.

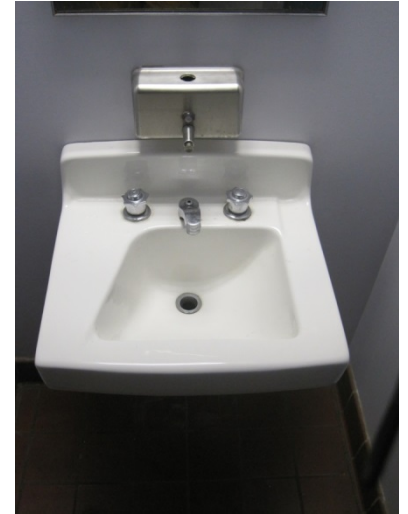
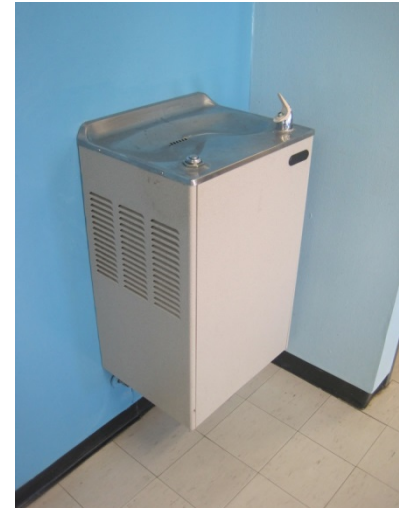
- Domestic hot water system should have a tempering valve added to it.
- Fixtures are not as efficient as current low flow fixtures – replacement would have a significant reduction of water consumption
- Many fixtures are not ADA compliant
- Install check valves on hot and cold water at janitor's sink

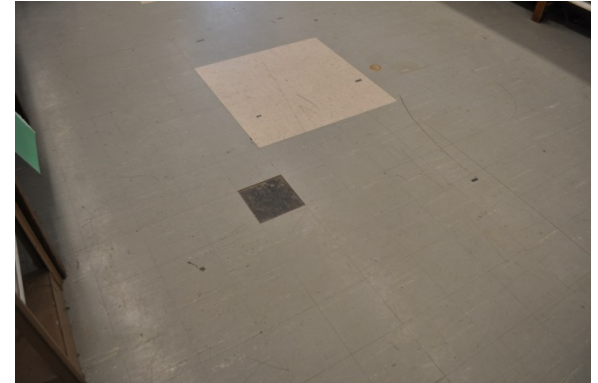
- At the time of original construction some suspect hazardous materials may have been utilized
- These materials are typically benign unless disturbed by maintenance or renovations
- AHERA report update scheduled for Summer 2013; testing of any suspect materials and abatement will be required prior the start of any proposed construction.
